**Gold King Mine Spill Response Recommendation for Removal of Orange Sediment from “Eddy Pool Area” on the Animas River Adjacent to (b) (6) Property**

**(b) (6), Durango, Colorado 81301**

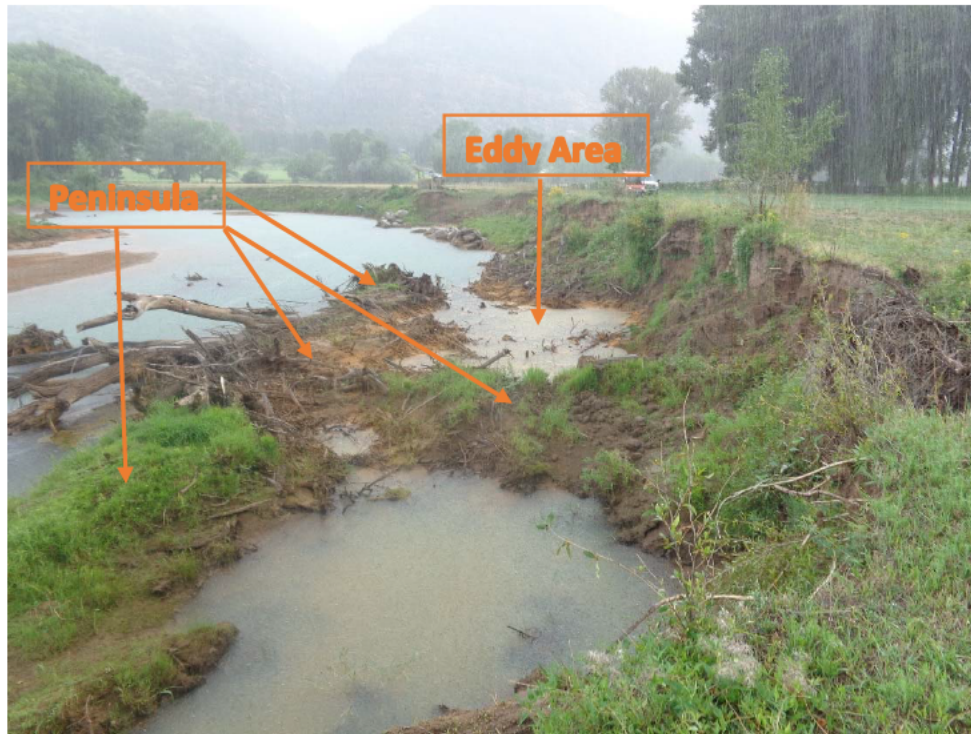
(b) (6) commented that the level of flow in the river is at historic lows right now and will be much higher in the upcoming rainy season. Higher water levels are evident by the large tree and sediment that make up the peninsula (see **Photograph 1**), which likely were once part of the adjacent embankment itself. When high water events occur, the eddy area is overtopped with flow that cuts away at the embankment, resulting in sloughing of soil and trees located at the edge of the embankment.

**Photograph 1:** Looking upriver at the eddy area created by the peninsula of a dead tree and sediment. Notice that the orange sediment is limited to the upriver side of the peninsula because water does not flow through to the pool of water in the foreground.

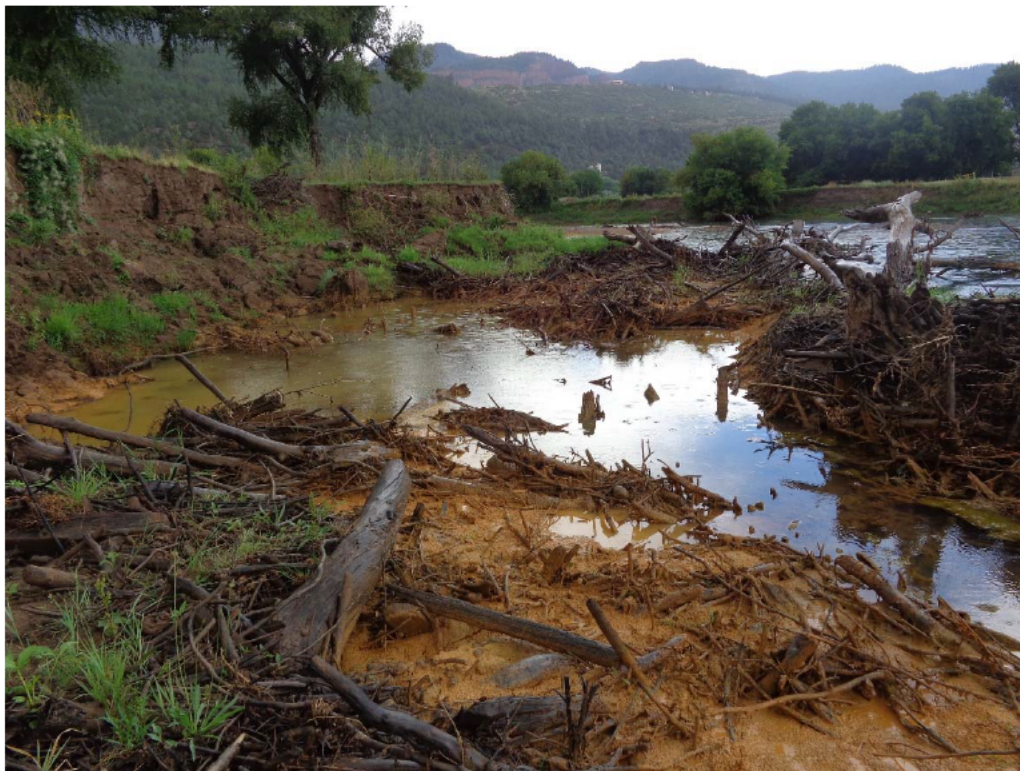
The “eddy area” is a location along the eastern embankment of the river where tree stumps and river debris have collected, creating an area where the current low-level of water in the river does not flow through, thereby creating an eddy in the water. Without flow, the orange sediment in the eddy area has not been flushed naturally down the river (see **Photographs 1 and 2**). Ms. Wagner explained that artificial flushing is an acceptable means to remove the orange sediment and involves the use of a water truck with a pump and fire hose to spray (i.e., flush) the orange sediment from the area.

**Photograph 2:** Eddy area with orange sediment. Looking downriver.

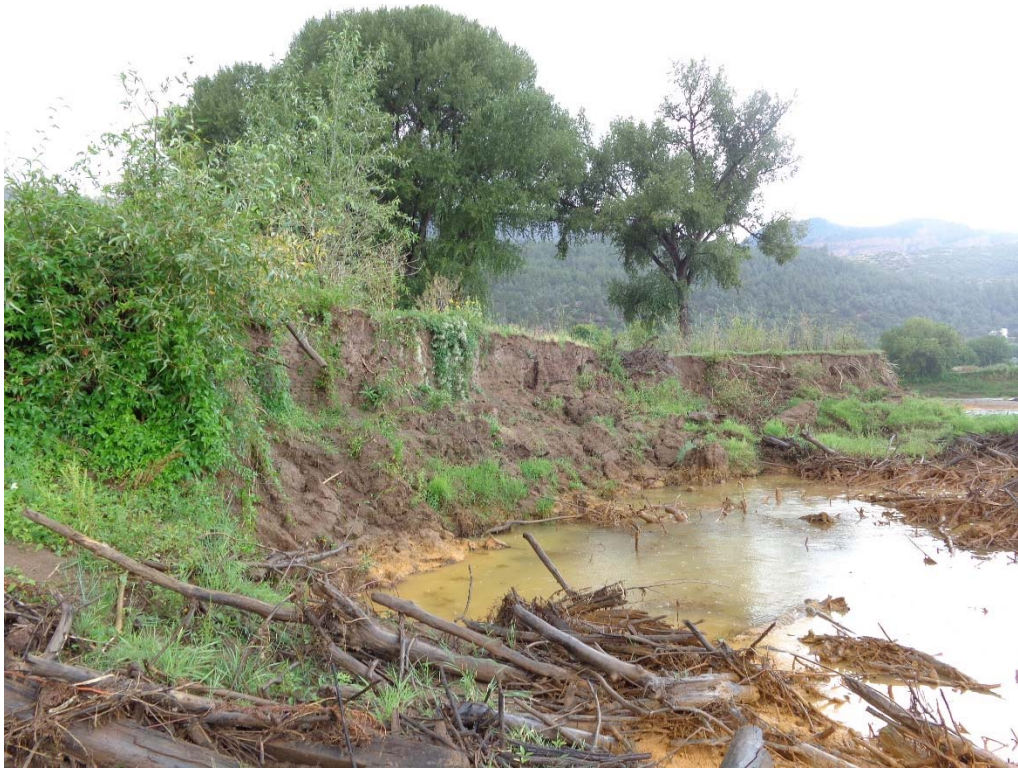
It was explained to (b) (6) that any cuts EPA makes in the peninsula to create flow-through will be backfilled up to existing conditions (i.e., current elevation) and, therefore, future high-flow events would still overtop the existing eddy area and continue to erode the embankment (see **Photographs 3 and 4**).

**Photograph 3:** Embankment (approximately 8 to 10 feet in height) located adjacent to the eddy area.

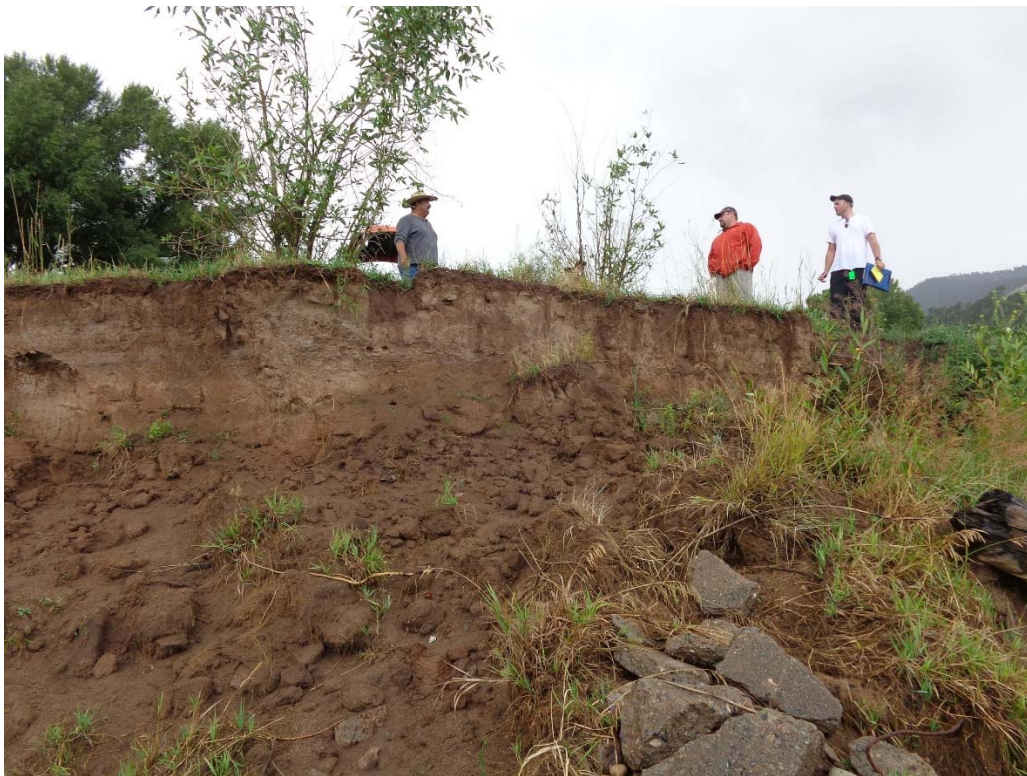
**Photograph 4:** Looking up the embankment from the shoreline of the Animas River adjacent to the eddy area. Notice that the current embankment has recently sloughed.

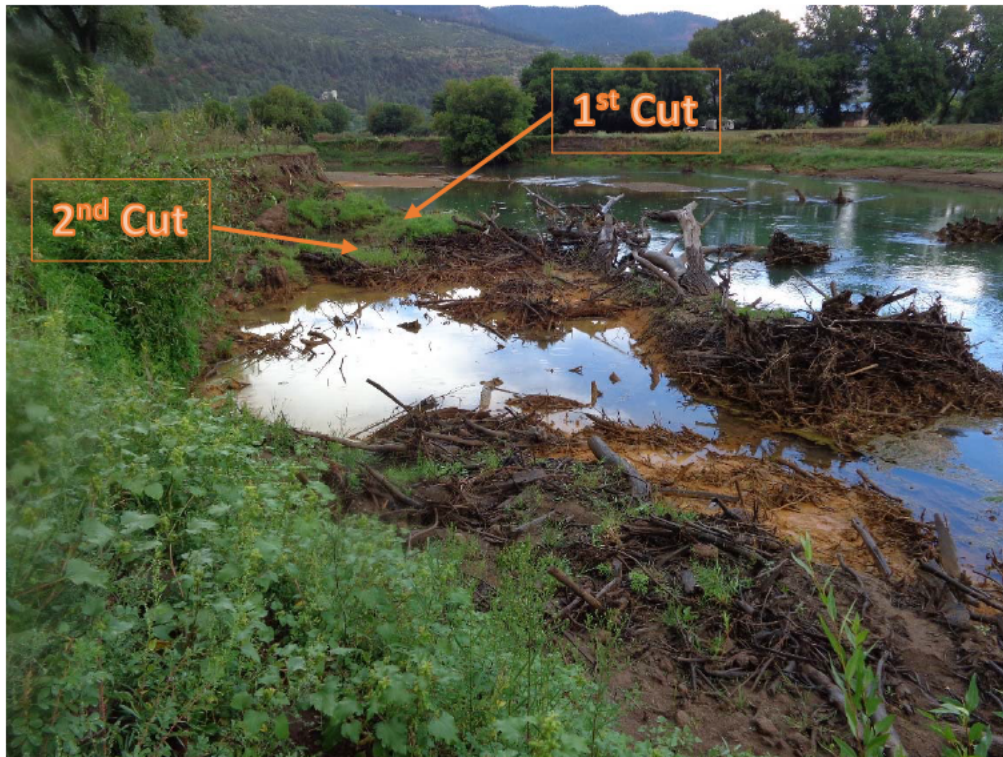
**Photograph 5:** Looking down at the eddy area from the shoulder of the embankment.

3. With the track hoe positioned on top of the embankment and as far back as possible from the shoulder of the embankment (with the operator still able to see the bottom of the eddy area), make two excavation cuts in the peninsula to create open-flow through the area (see **Photographs 5, 6, 7, and 8**). The main area of the peninsula with the dead tree will, in essence, become an island.

4. To avoid spreading the orange sediments to the “clean pool” sediments (located at the downstream side of the eddy area), the excavation cuts should be made from the downstream side of the peninsula with work progressing from downstream to upstream (see **Photographs 5, 6, 7, and 8**). In other words, the water in the eddy pool should be maintained as long as possible so that the last bucket of sediment removed from the 2<sup>nd</sup> cut finally releases the water.

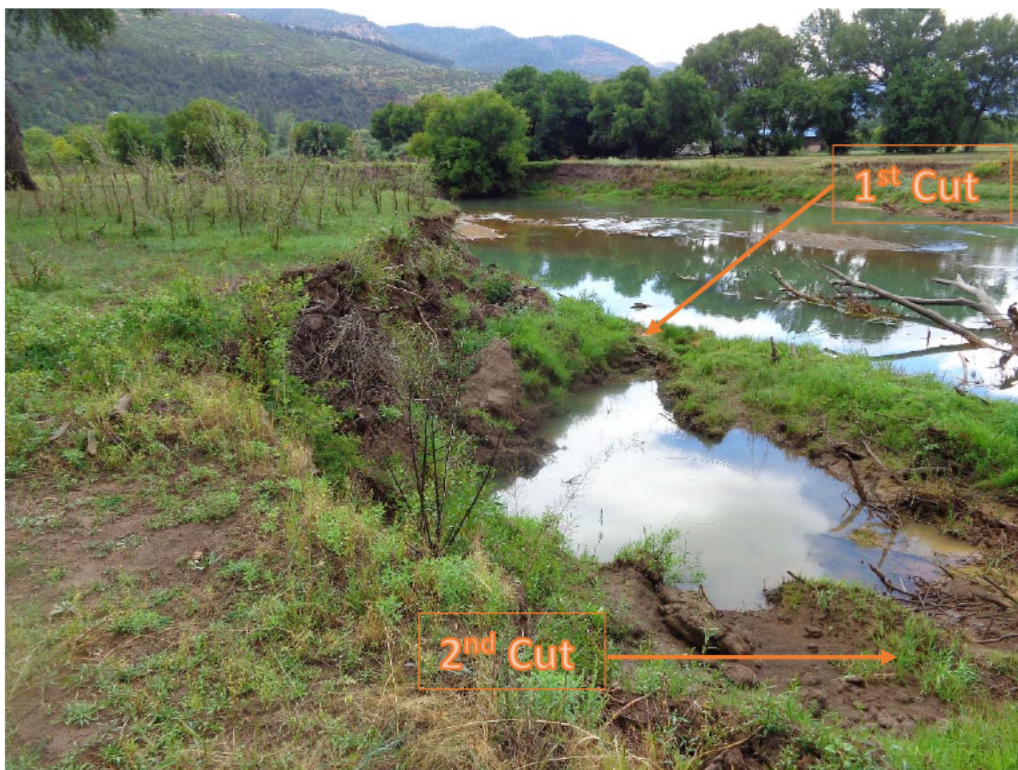
**Photograph 6:** Location where two cuts are recommended to create open flow through the eddy area to allow artificial flushing of the orange sediment out of the eddy area and downriver.

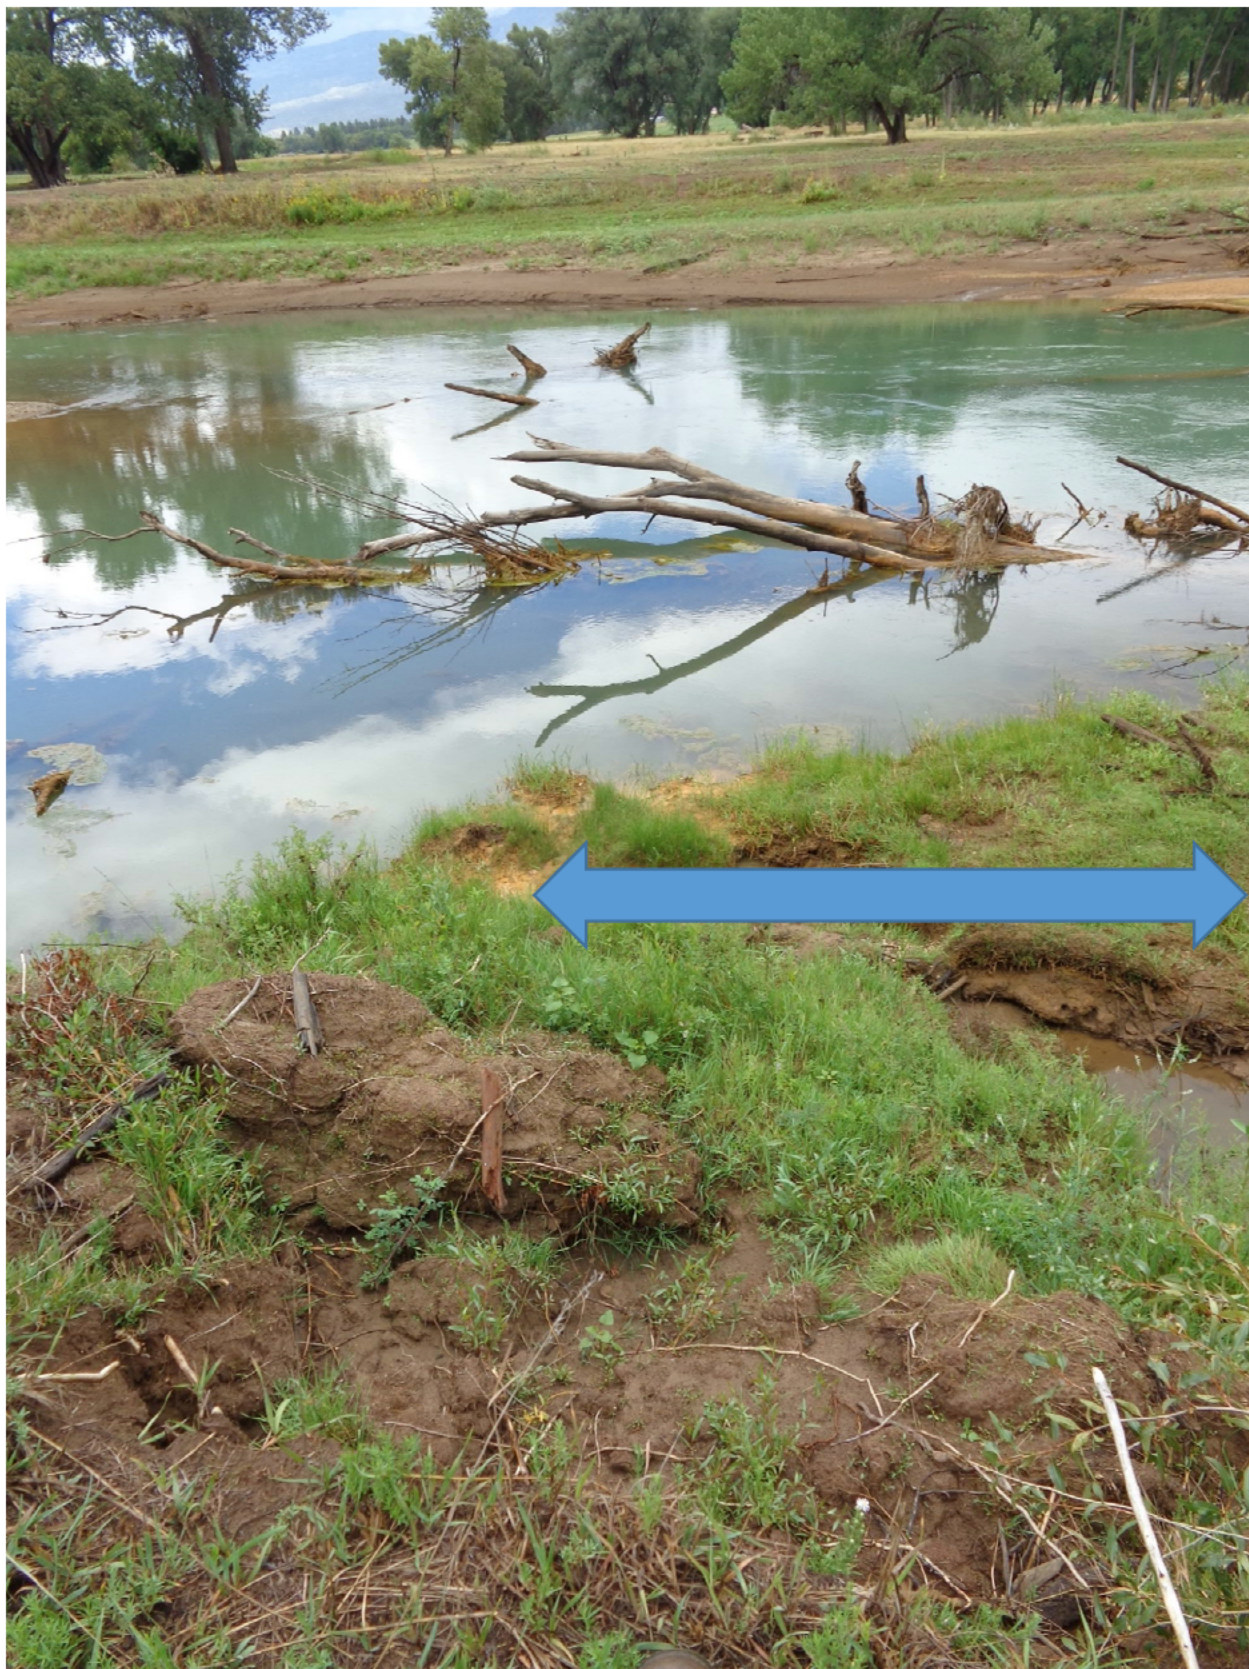
**Photograph 7: Location of recommended first cut. Looking downstream.**

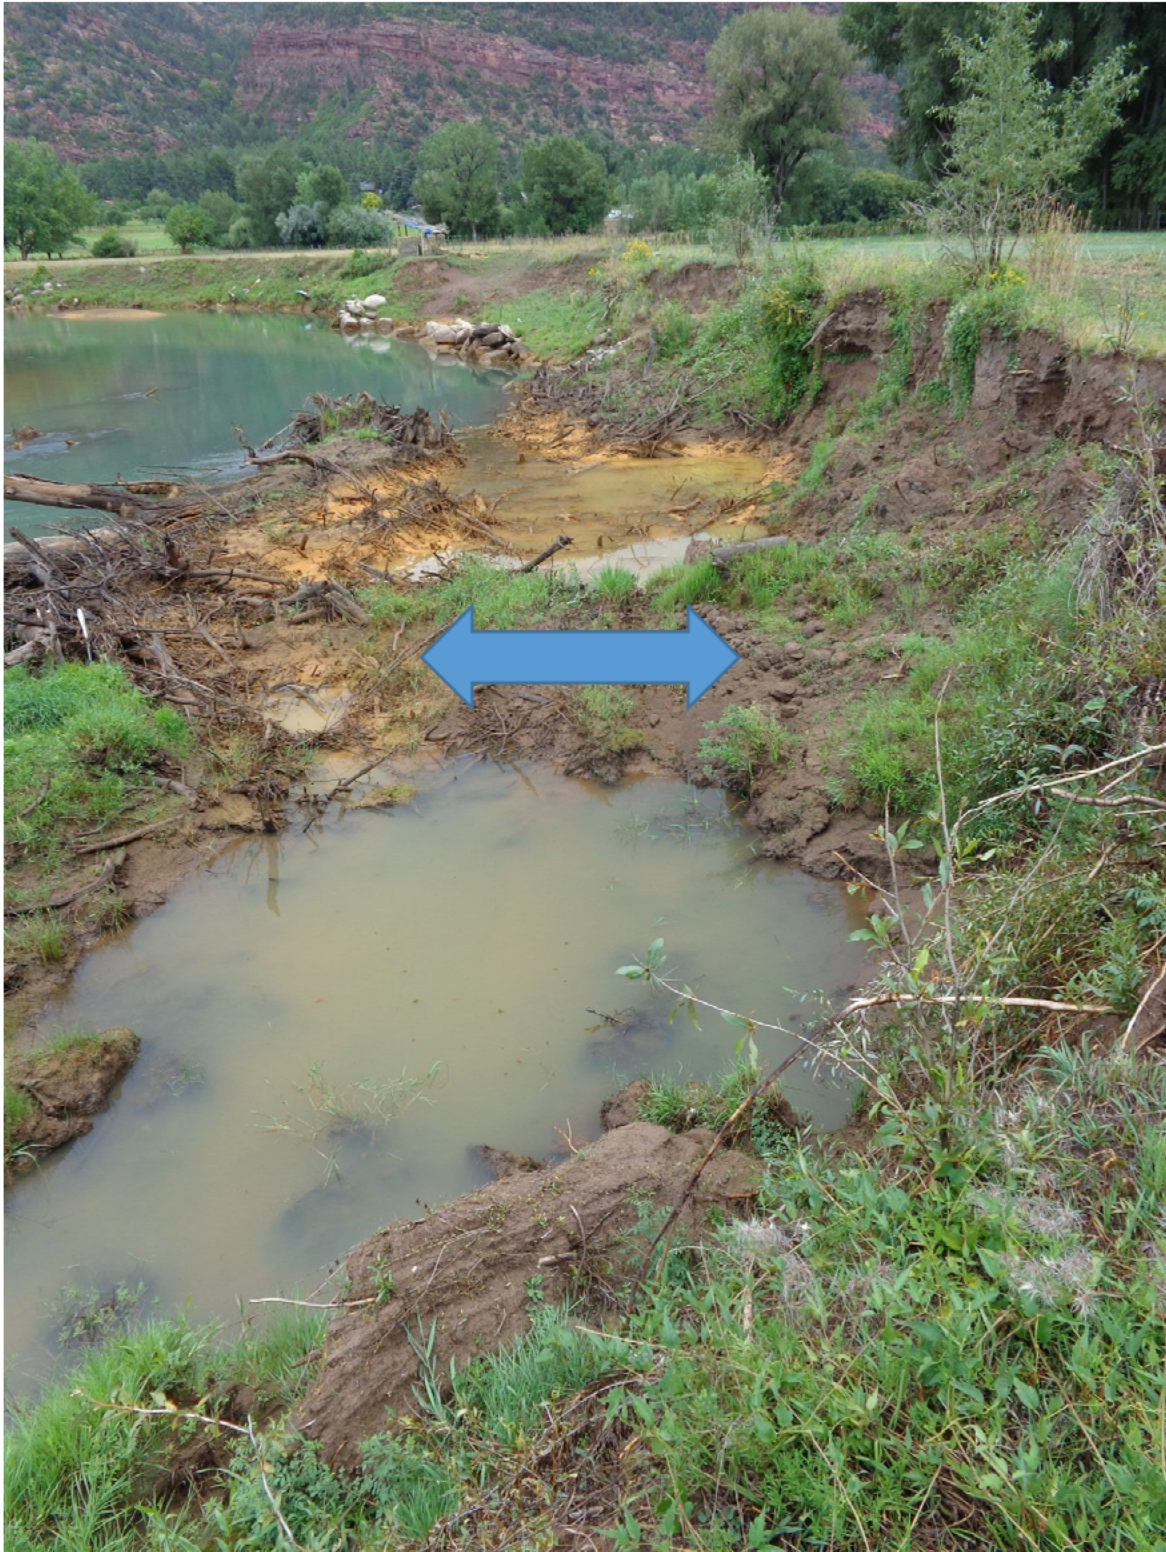
**Photograph 8:** Location of recommended second cut. Looking upstream.
